Understanding PV and fire risk on flat roofs

Property insurance in Europe

Tools of the trade

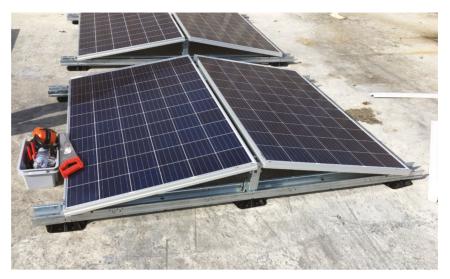
The configuration tested was of back-to-back roof mounted PV panels to reflect the most commonly used arrangement in Northern and Western Europe, where roof mounted panels are arranged in an alternating East/West-facing layout to make the most of the available sunlight. Whilst the test results are specific to the flat roof and PV products and configurations that were tested and the circumstances of those tests, in both rounds of tests there was no significant difference between the extent of horizontal fire spread, which was very limited beyond the perimeter of the PV array in all cases. With the build-ups insulated with the FM Approved PIR, roof deck

Back-to-back roof mounted PV panels
